**From:** [Gary Miller](#)  
**To:** [Paul.R.Schroeder@erdc.dren.mil](#)  
**Cc:** [Valmichael Leos](#); [Carlos Sanchez](#); [Jessica Hernandez](#); [Anne Foster](#); [Hayter, Earl J ERDC-CHL-MS](#)  
**Subject:** Armored Cap Analysis - San Jacinto River waste Pits Superfund Site  
**Date:** 07/26/2012 11:58 AM  
**Attachments:** [SJ IMG\\_1864.jpg](#)  
[SJ IMG\\_1872.jpg](#)  
[SJ IMG\\_1871.jpg](#)  
[SJ IMG\\_1869.jpg](#)  
[SJ IMG\\_1867.jpg](#)

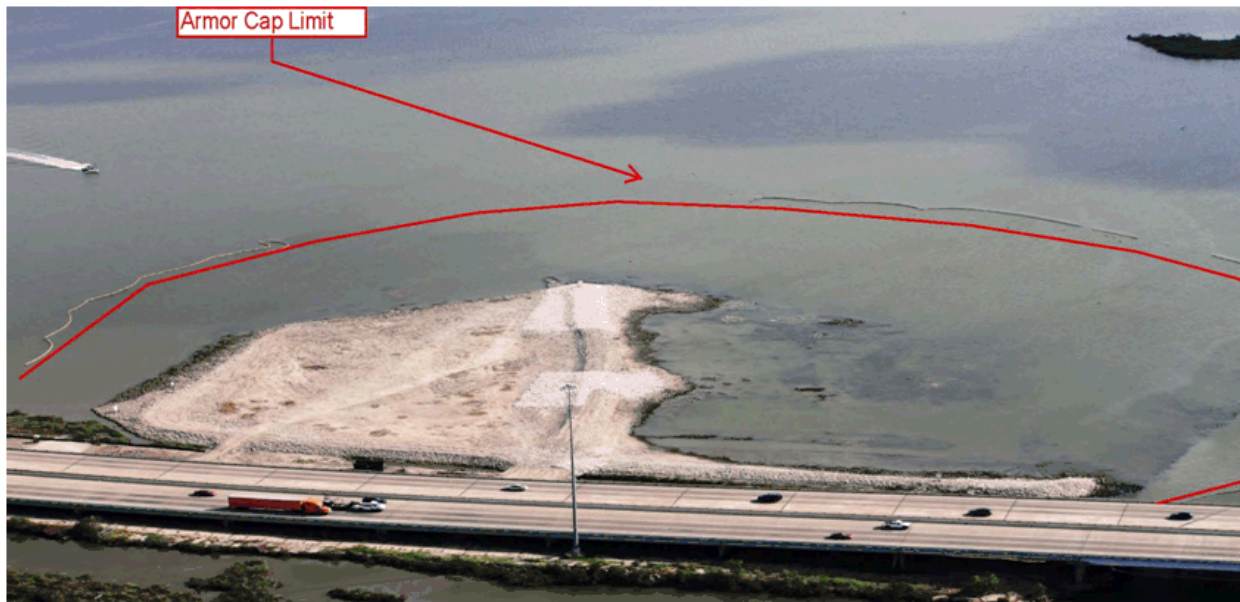
For your information, the armored cap (aerial picture below, before flood) is constructed over waste pits containing dioxin. The cap was constructed in 2011 by respondents under a consent order issued by EPA and was designed for a 100-year flood. This cap is exposed to the San Jacinto River, and recent flooding caused erosion (see attached pictures) of the cover material on the west side (left side of aerial picture below). While all the facts are still being gathered, it appears that the river flow may have been less than a 10-year flood, well below the design flood.
